UNDERSTANDING DEVICE LIMITATIONS AND SOLUTIONS

Troubleshooting inappropriate therapy for lead fractures and electromagnetic interference

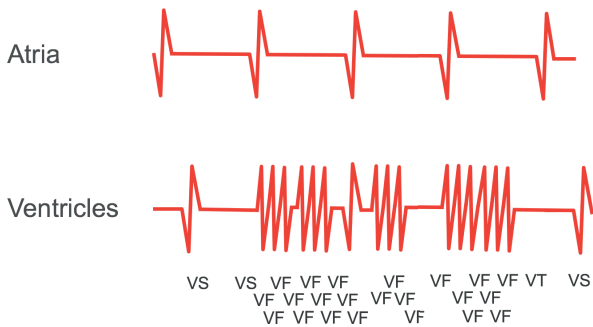
Lead fracture

- Fractured leads need to be replaced.
- RV lead noise discriminators can prevent inappropriate therapy in lead fractures.
- Patients should not be in close proximity to sources of significant EMI.
